**Durand Building**  
637 S. Wood St.  
Chicago, IL

Specialty Consulting, Inc.  
2942 W. Van Buren St.  
Chicago, Illinois 60612

*Hazardous Materials Building Survey Report  
Durand Building  
637 S. Wood Street  
Oak Forest, Illinois*

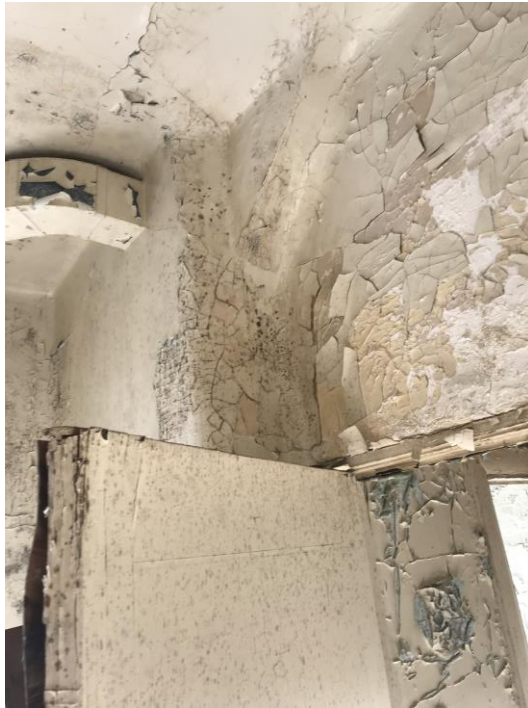
**Photo Location:**  
Room 403

**Material Description:**  
Hard Plaster

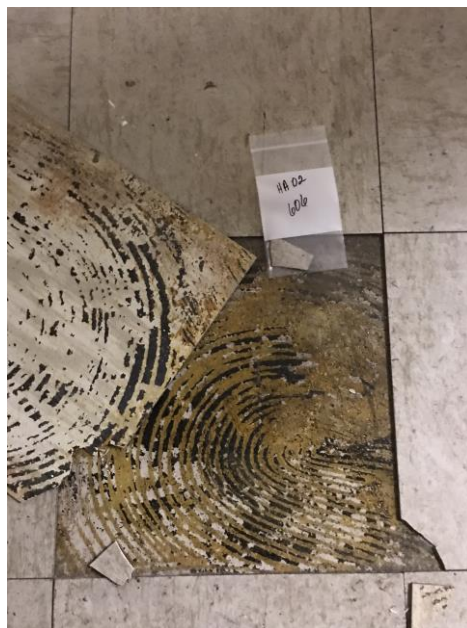
**Photo Location:**  
Room 606

**Material Description:**  
12"x12" Beige w/ Stripes  
VFT & Mastic

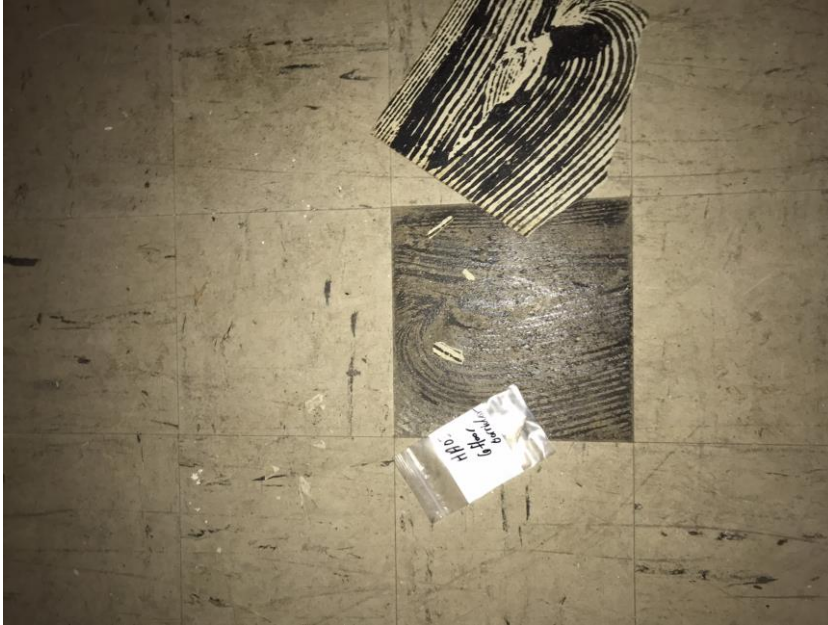
**Photo Location:**  
6th Floor Corridor

**Material Description:**  
9" x 9" Vinyl Floor Tile and  
Mastic- Beige with Black  
Streaks

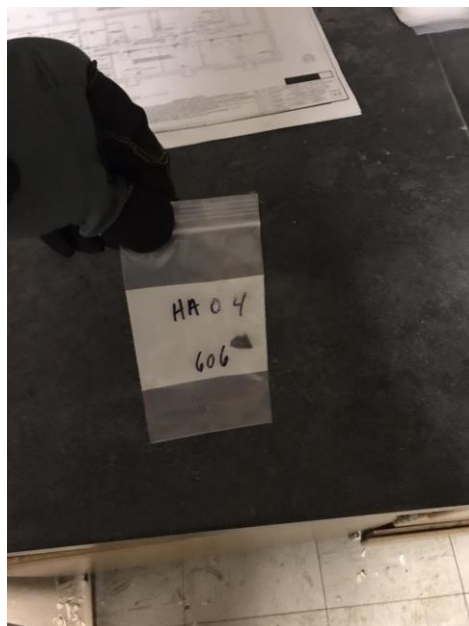
**Photo Location:**  
Room 606

**Material Description:**  
Black Counter Top

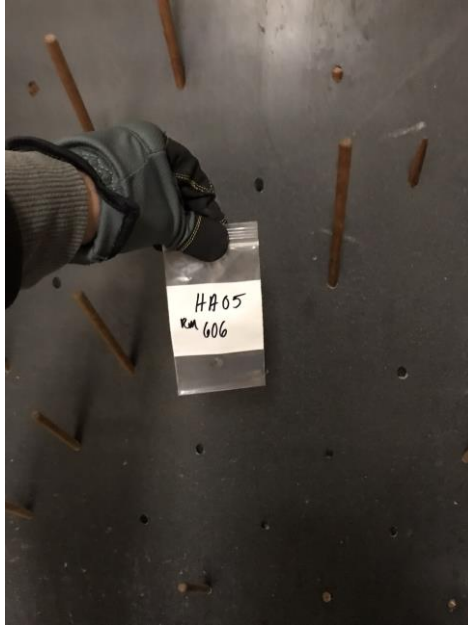
**Photo Location:**  
Room 606

**Material Description:**  
Black Splash Tops

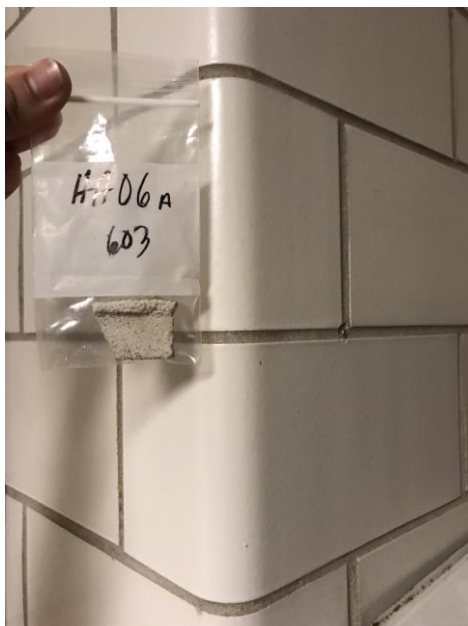
**Photo Location:**  
Room 603

**Material Description:**  
Glazed Block & Mortar

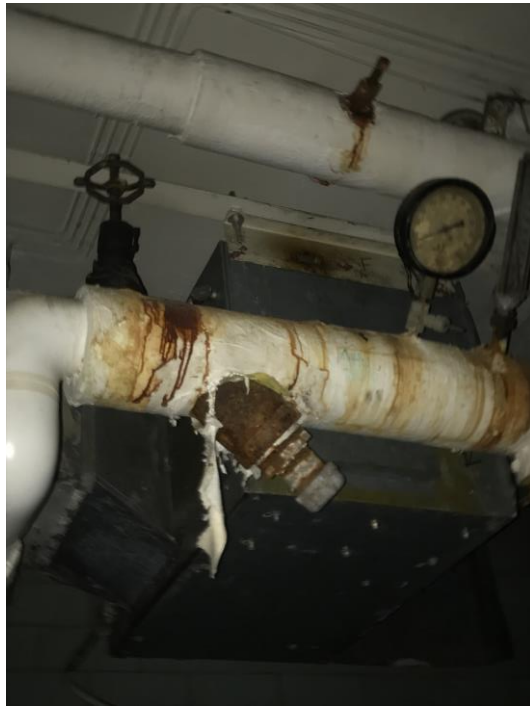
**Photo Location:**  
Room 606

**Material Description:**  
MJP on Fiberglass Pipe  
Insulation

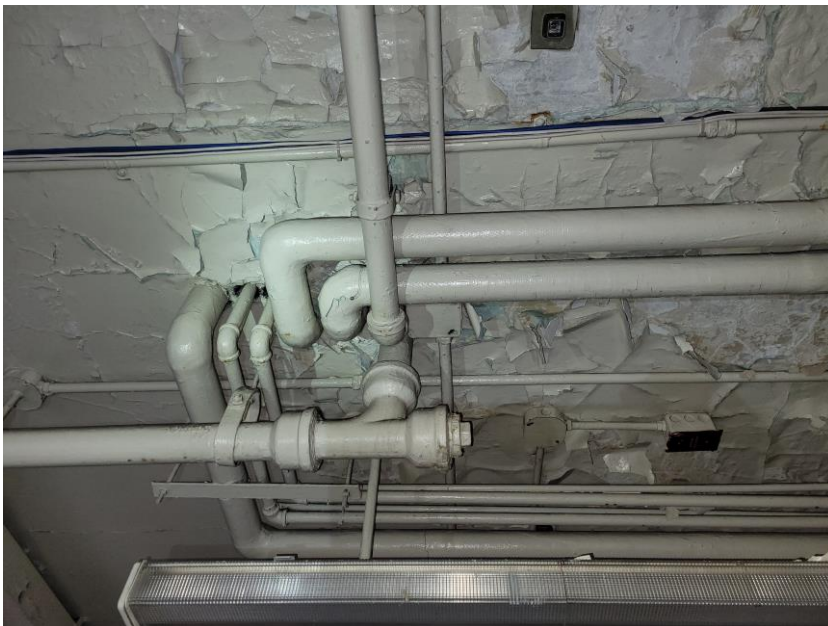
**Photo Location:**  
303

**Material Description:**  
Aircell Pipe Insulation &  
MJP

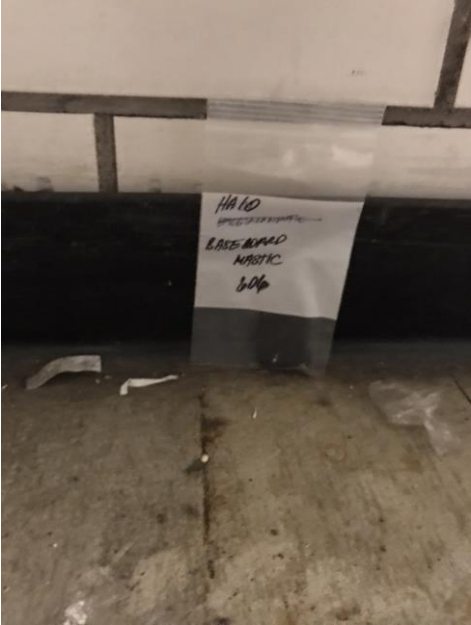
<b>Material Description:</b> Baseboard & Mastic
		<b>Photo Location:</b> Room 606
<b>Durand Building</b> 637 S. Wood St. Chicago, IL

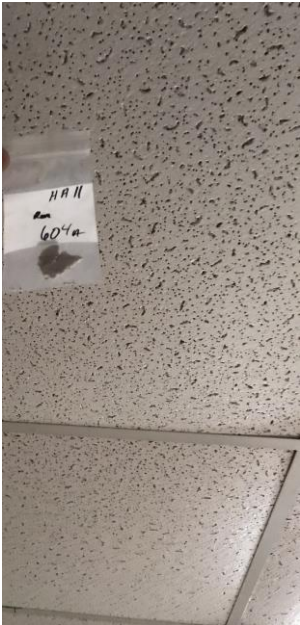
<b>Material Description:</b> 2'x4' Ceiling Tile
		<b>Photo Location:</b> Room 604
<b>Durand Building</b> 637 S. Wood St. Chicago, IL

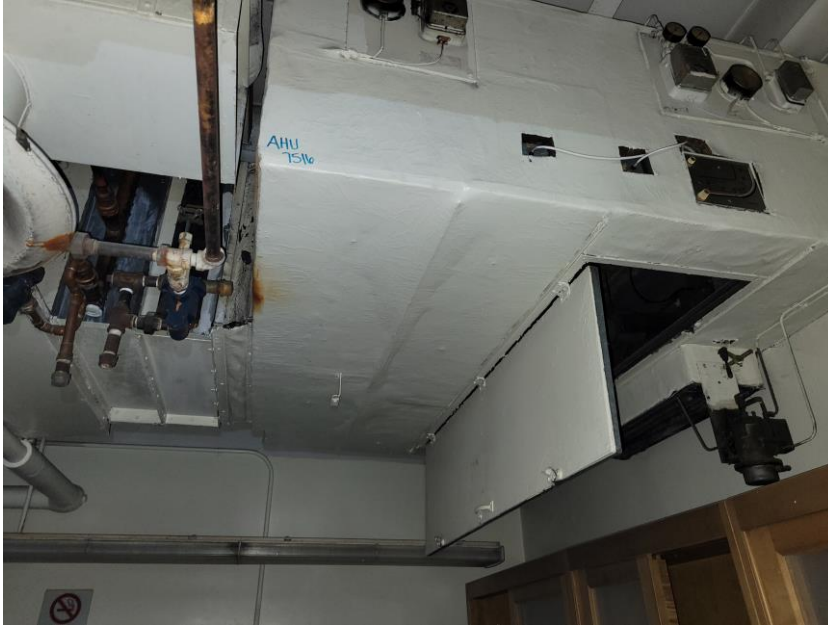
**Photo Location:**  
512

**Material Description:**  
Duct Insulation

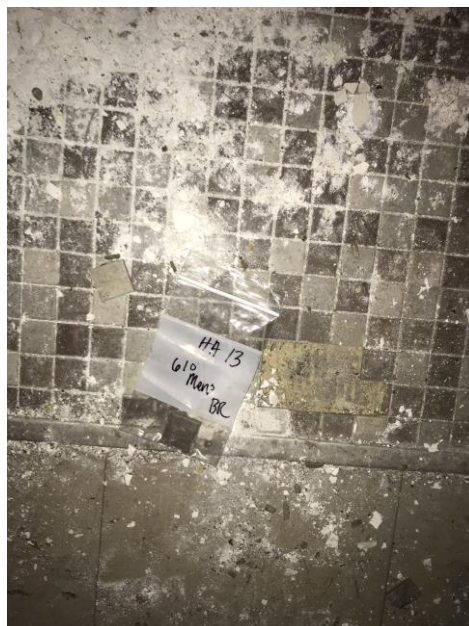
**Material Description:**  
Ceramic Tile & Grout

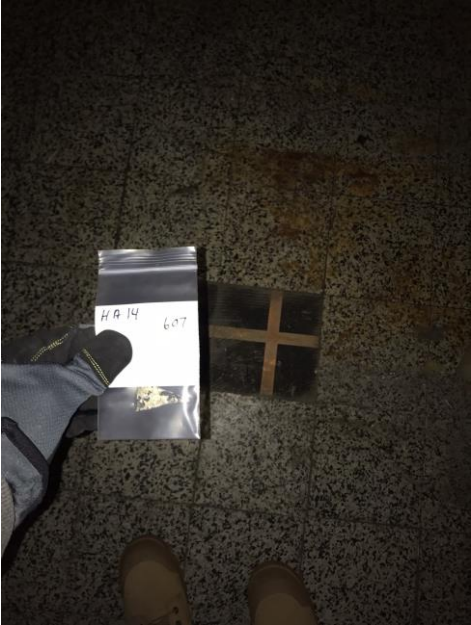
<b>Material Description:</b> 9" x 9" Vinyl Floor Tile and Mastic- Black and White	
	<b>Photo Location:</b>	
<b>Durand Building</b> 637 S. Wood St. Chicago, IL

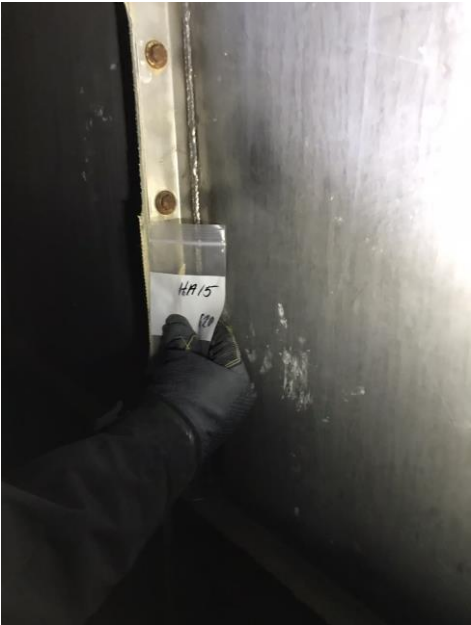
<b>Material Description:</b> Incinerator Insulation	
	<b>Photo Location:</b>	
<b>Durand Building</b> 637 S. Wood St. Chicago, IL

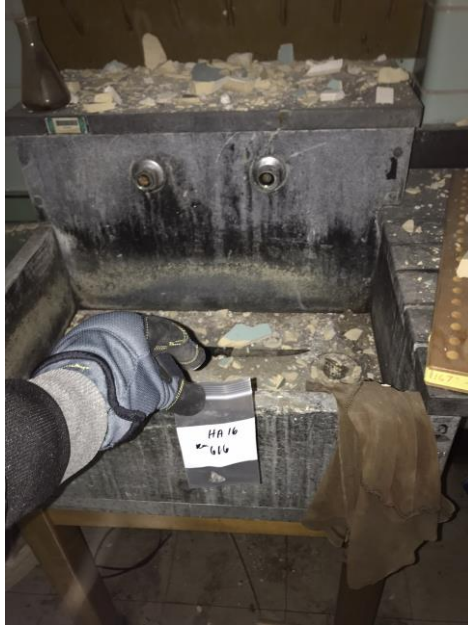
**Material Description:**  
Sink

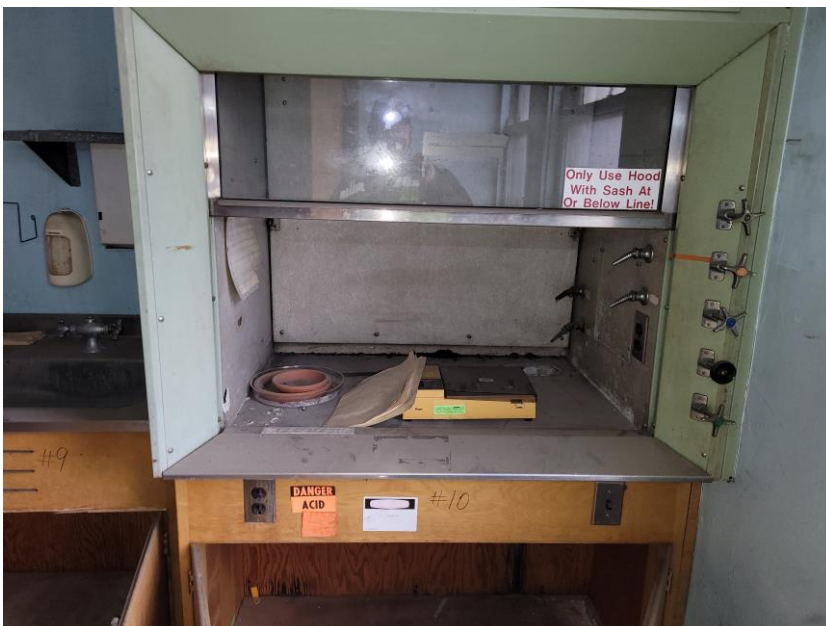
**Photo Location:**  
412

**Material Description:**  
Fume Hood Panel

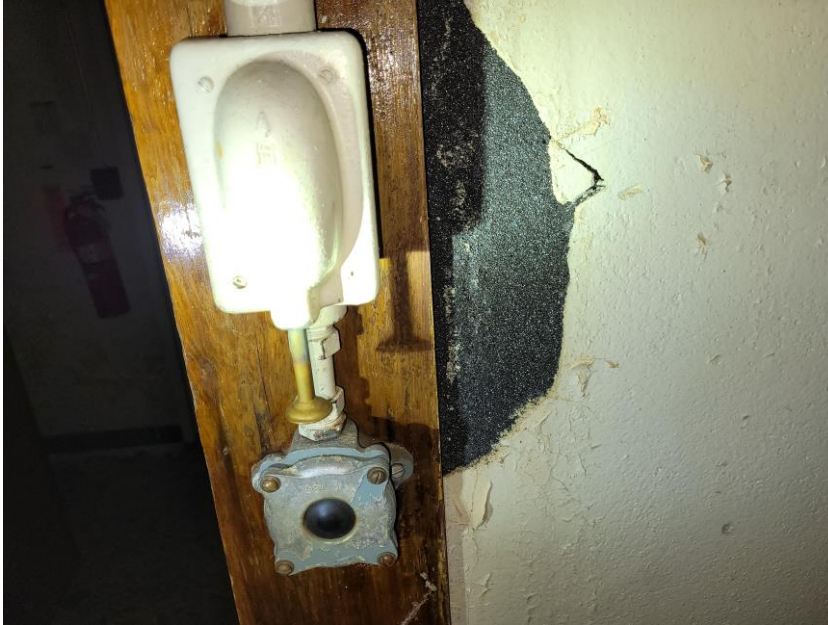
**Photo Location:**  
505

**Material Description:**  
Black Panel Insulation /  
Adhesive

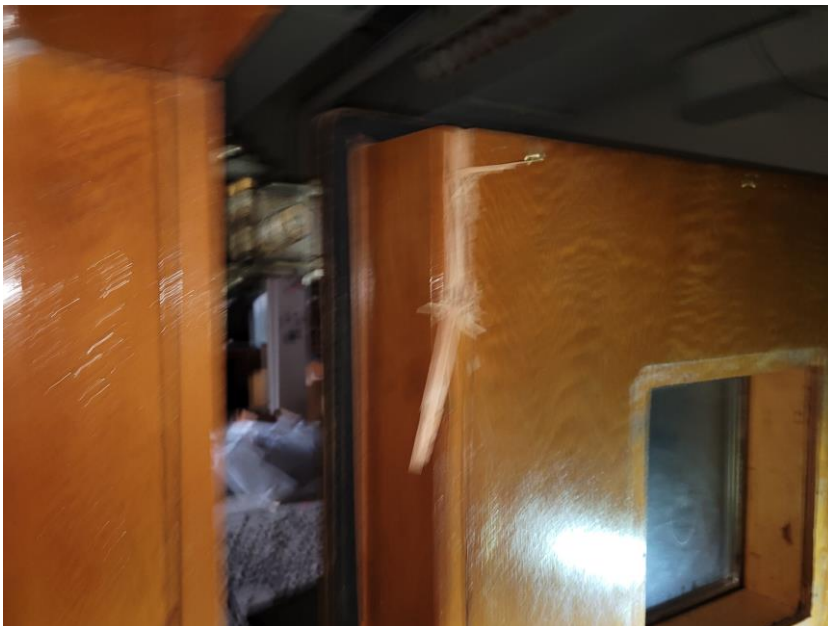
**Photo Location:**  
505

**Material Description:**  
Fridge Door Sealant

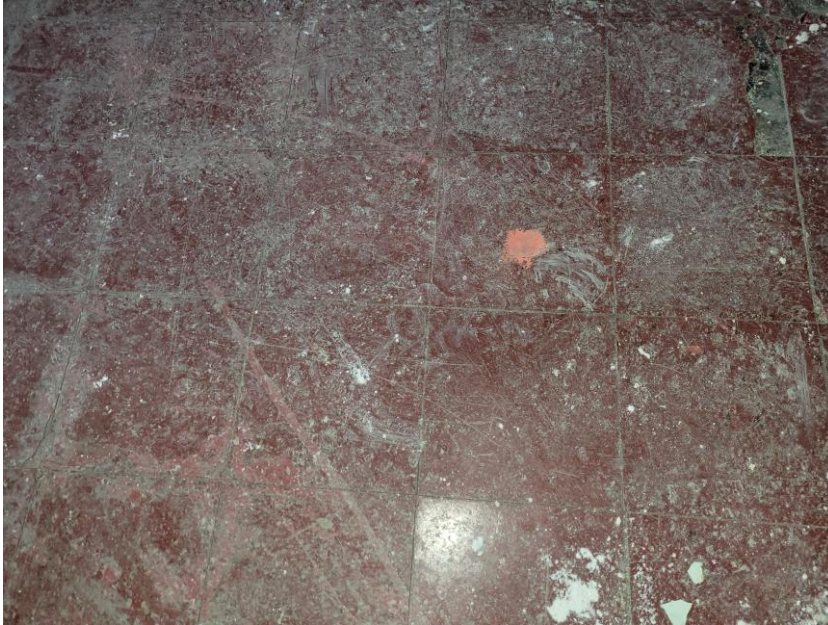
**Photo Location:**  
303

**Material Description:**  
9" x 9" Vinyl Floor Tile and  
Mastic- Red with White  
Stripes

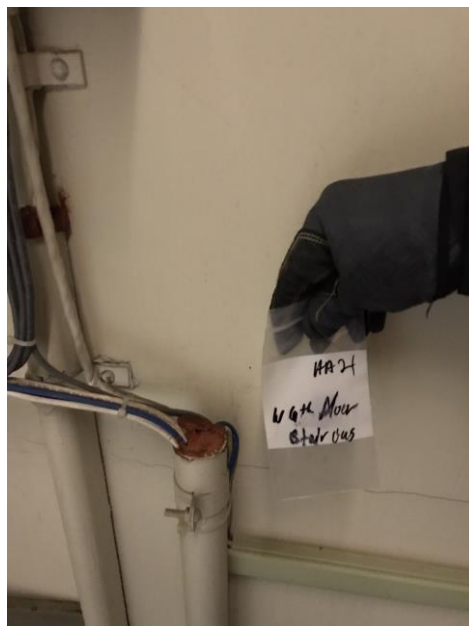
**Photo Location:**  
6<sup>th</sup> Floor Stairwell

**Material Description:**  
Red Fire Stop Caulk

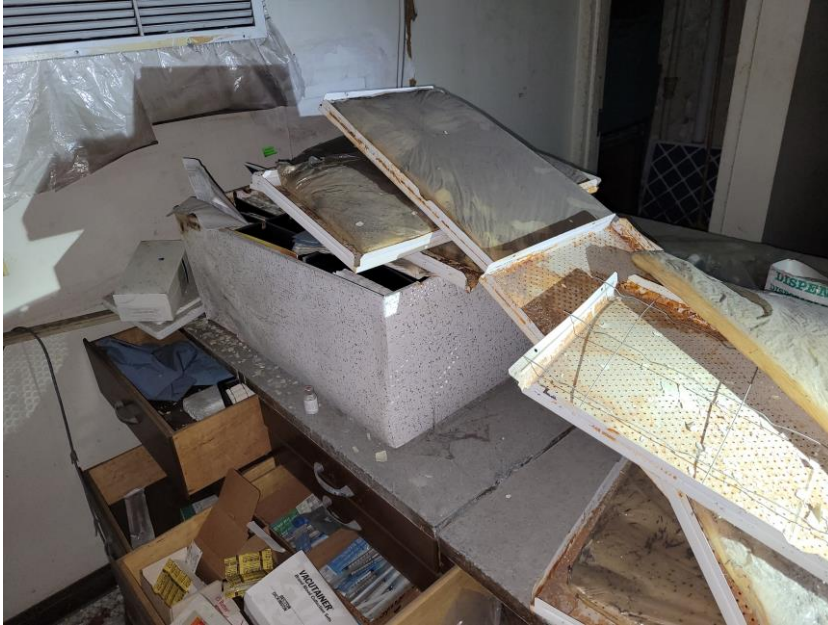
**Photo Location:**  
412

**Material Description:**  
Metal Ceiling Tile Insulation

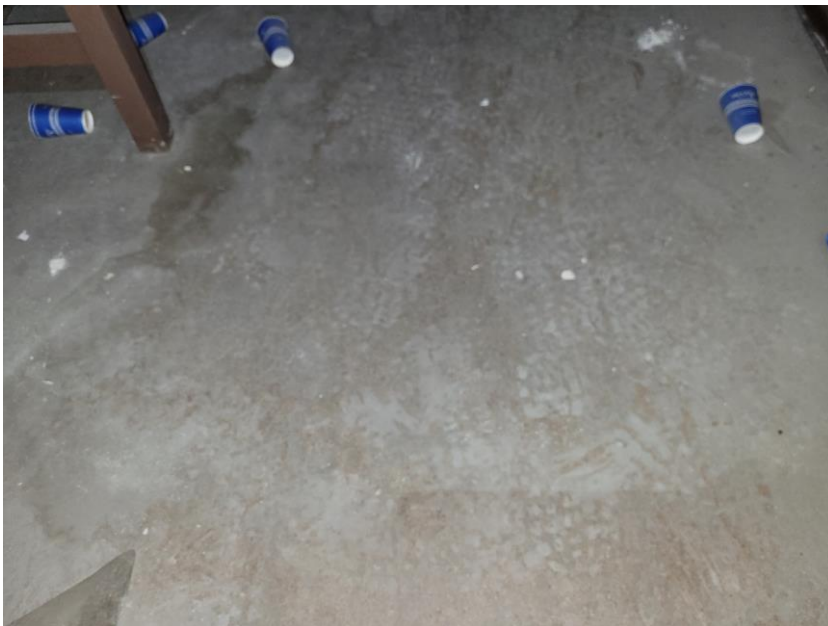
**Photo Location:**  
313

**Material Description:**  
Linoleum

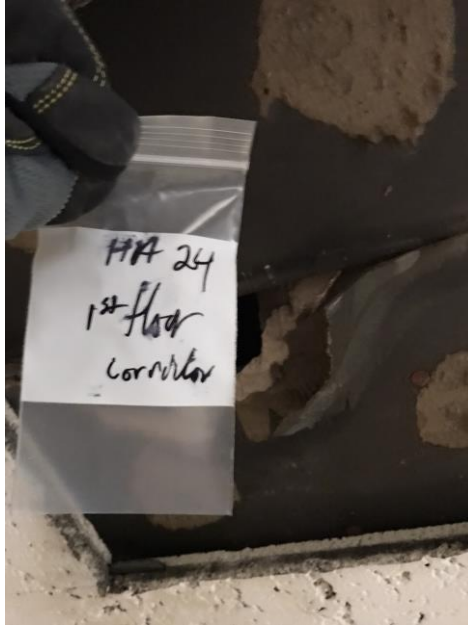
**Material Description:**  
Drywall System

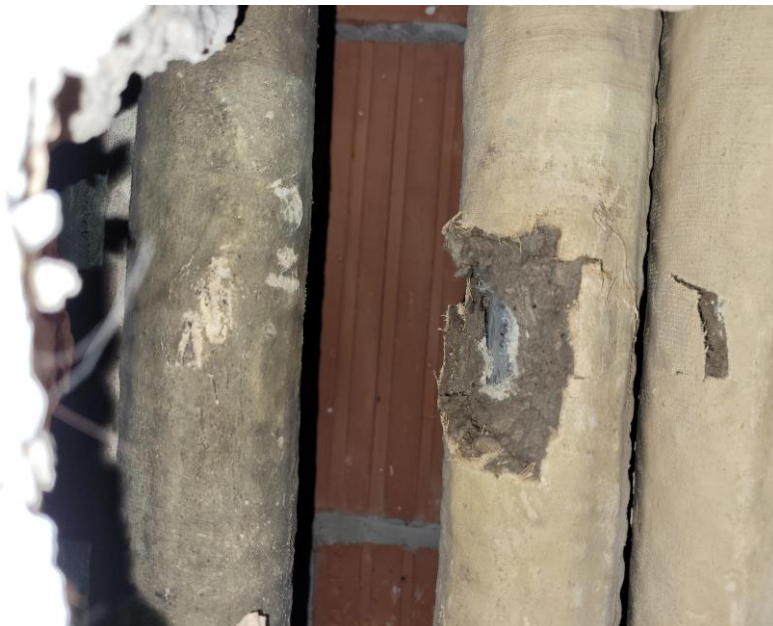
**Photo Location:**  
Pipe Chase

**Material Description:**  
Paper Wrap Insulation &  
MJP

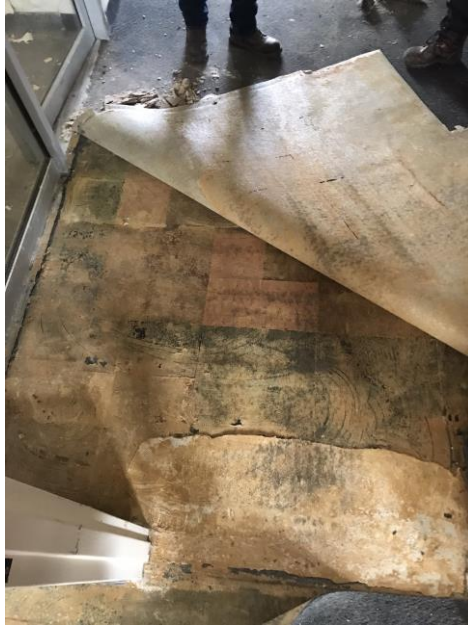
**Photo Location:**  
1st Floor Corridor

**Material Description:**  
Carpet & Mastic

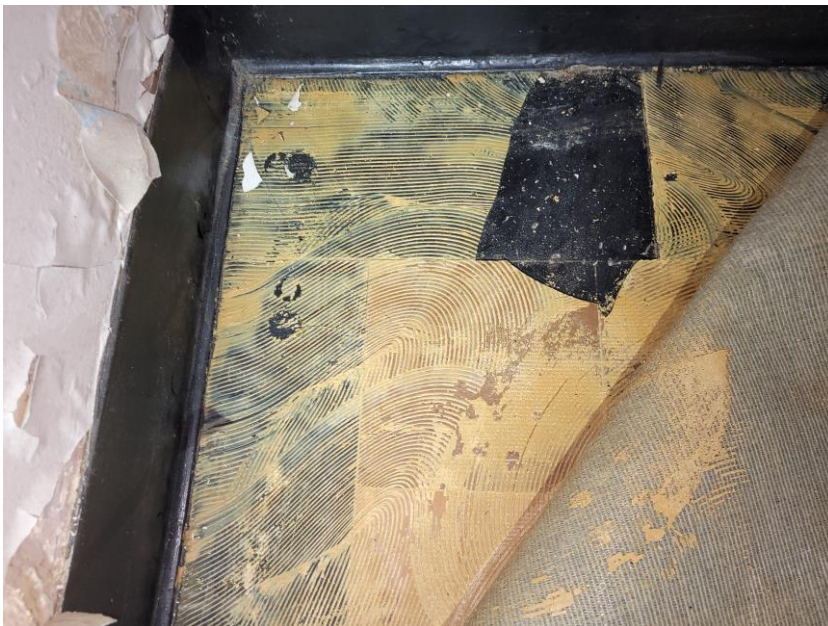
**Photo Location:**  
111

**Material Description:**  
9" x 9" Vinyl Floor Tile and  
Mastic- Brown

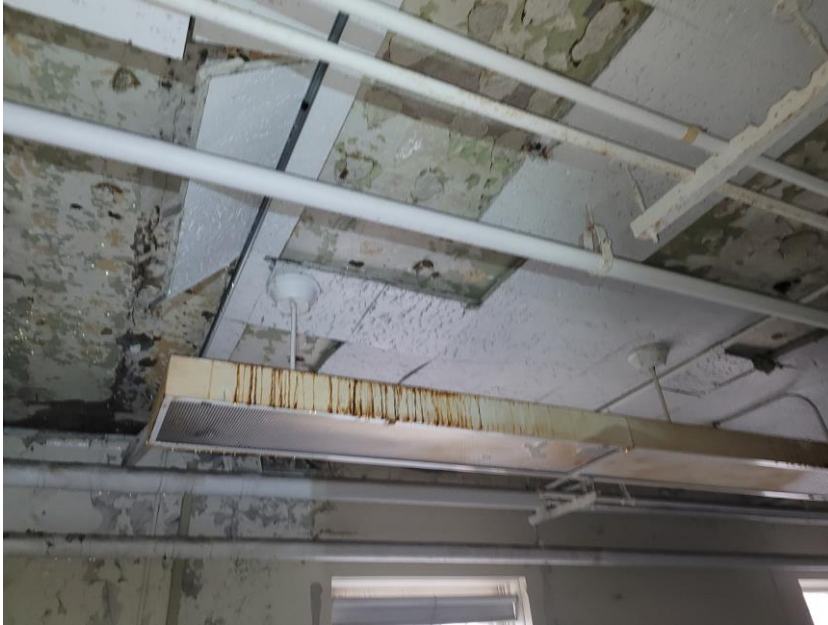
**Photo Location:**  
127

**Material Description:**  
1' x 1' Ceiling tile and Glue Puck

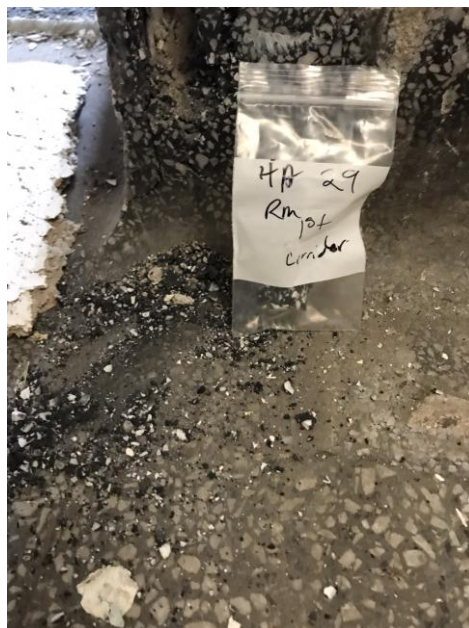
**Photo Location:**  
1st Floor Corridor

**Material Description:**  
Terrazzo

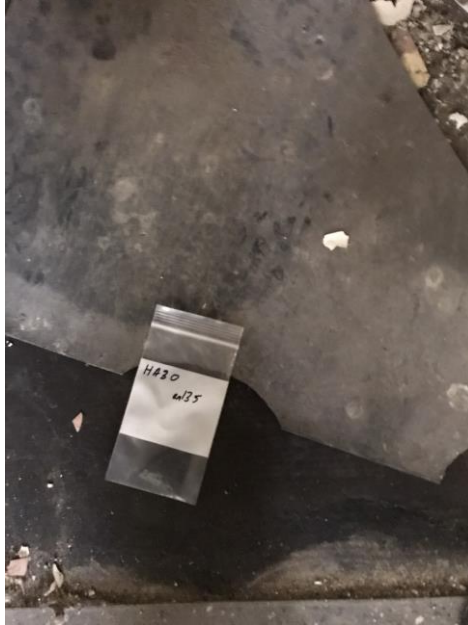
**Material Description:**  
18" x 24" Vinyl Floor Tile  
and Mastic - Black

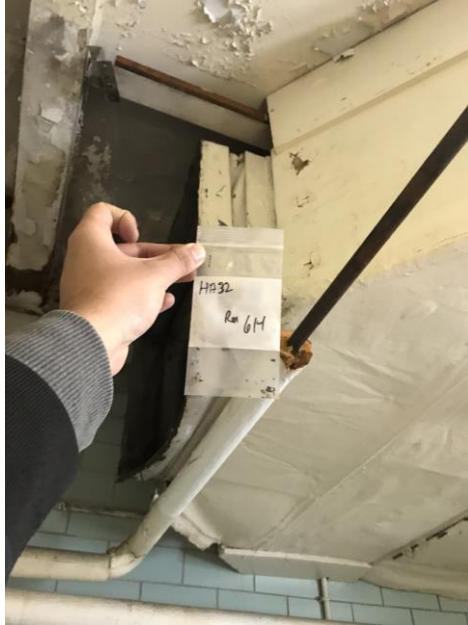
**Photo Location:**  
Room 614

**Material Description:**  
Vibration Damper Cloth

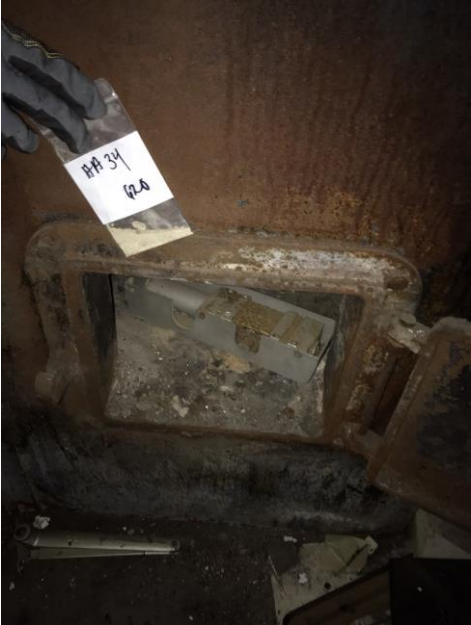
<b>Material Description:</b> Incinerator Soot	
	<b>Photo Location:</b>	
<b>Durand Building</b> 637 S. Wood St. Chicago, IL

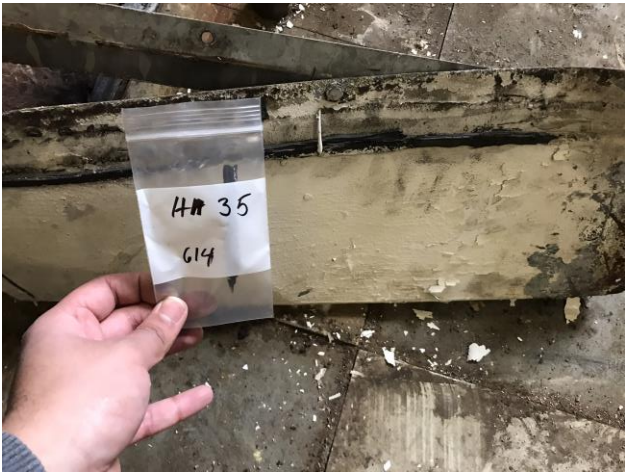
<b>Material Description:</b> Duct Sealant	
	<b>Photo Location:</b> Room 614	
<b>Durand Building</b> 637 S. Wood St. Chicago, IL

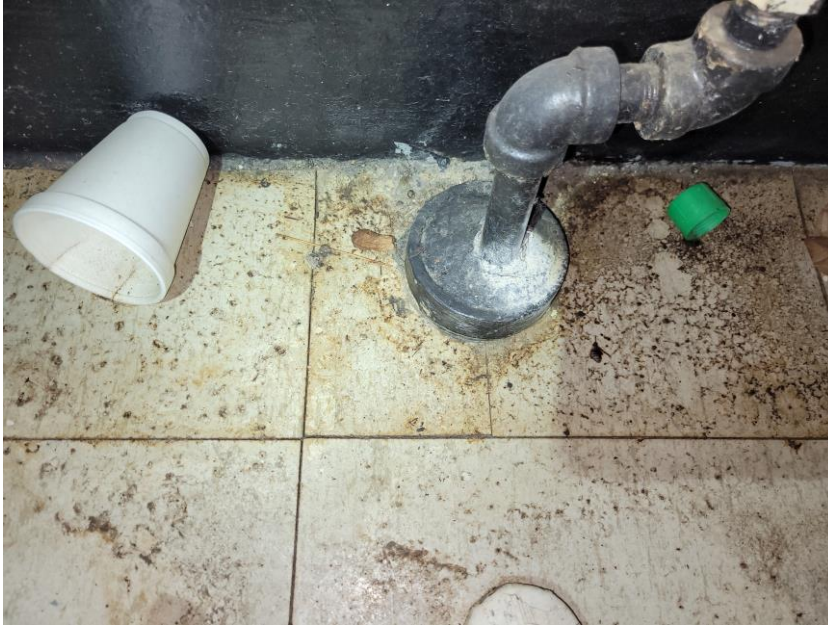
**Photo Location:**  
Room 615

**Material Description:**  
Fire Stop Packing Material

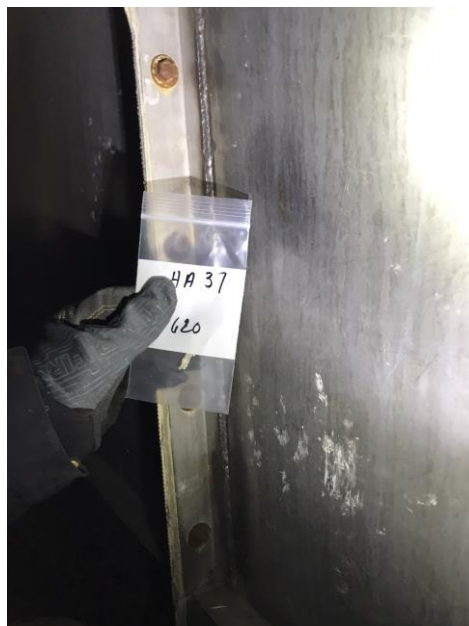
**Material Description:**  
Incinerator Sealant

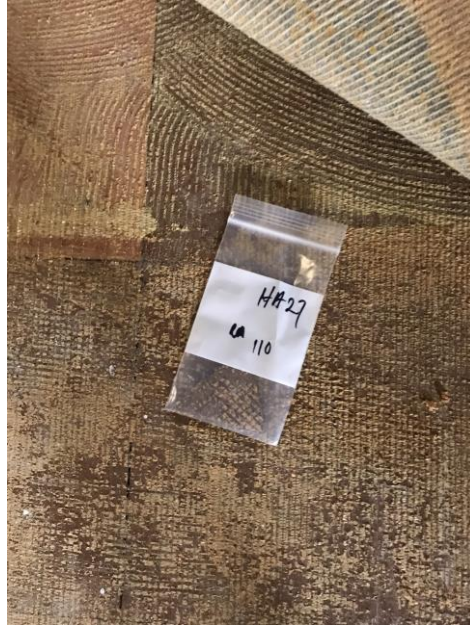
**Material Description:**  
9" x 9" Vinyl Floor Tile and  
Mastic- Black

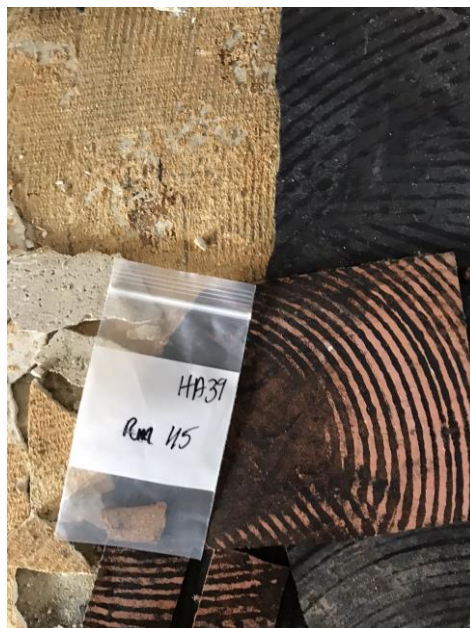
**Photo Location:**  
Room 115

**Material Description:**  
9" x 9" Vinyl Floor Tile and  
Mastic- Beige

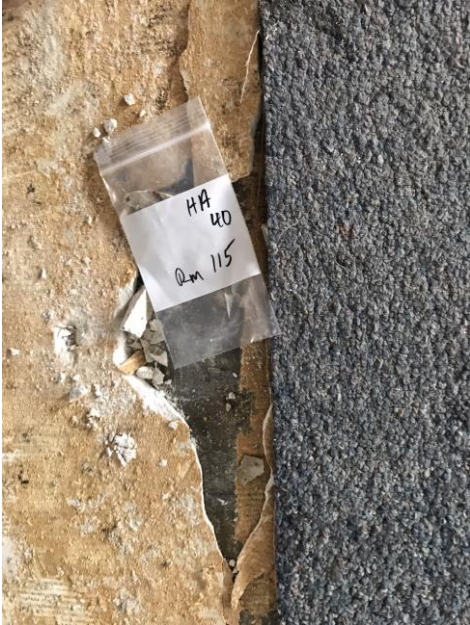
<b>Material Description:</b> Leveling Compound	
	<b>Photo Location:</b> Room 115	
<b>Durand Building</b> 637 S. Wood St. Chicago, IL

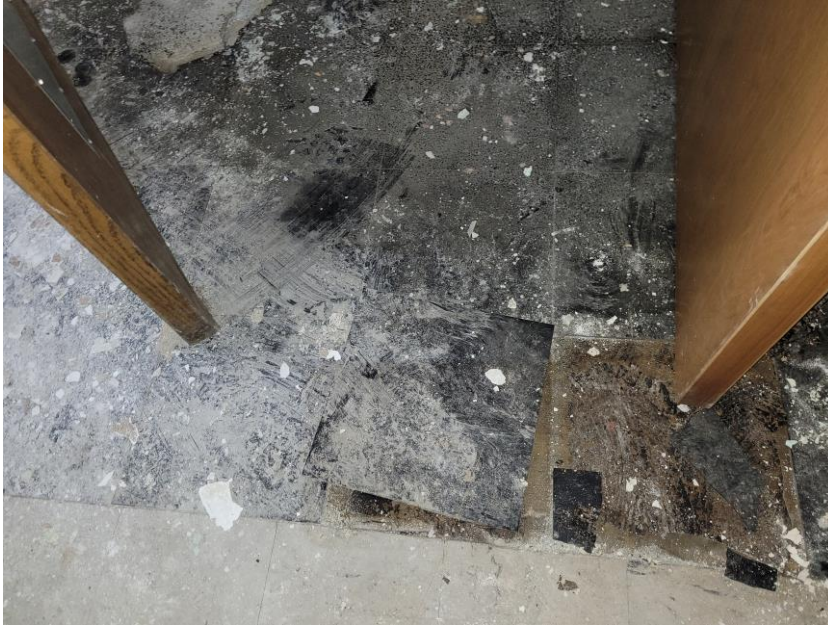
**Photo Location:**  
Outside 304

**Material Description:**  
12" x 12" Vinyl Floor Tile  
and Mastic- Black

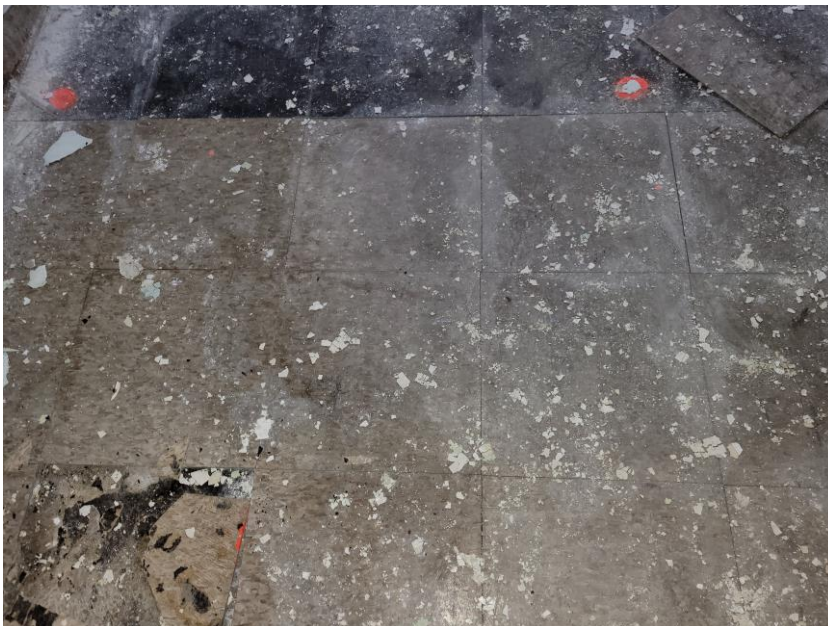
**Photo Location:**  
303

**Material Description:**  
12" x 12" Vinyl Floor Tile  
and Mastic- Black/Beige

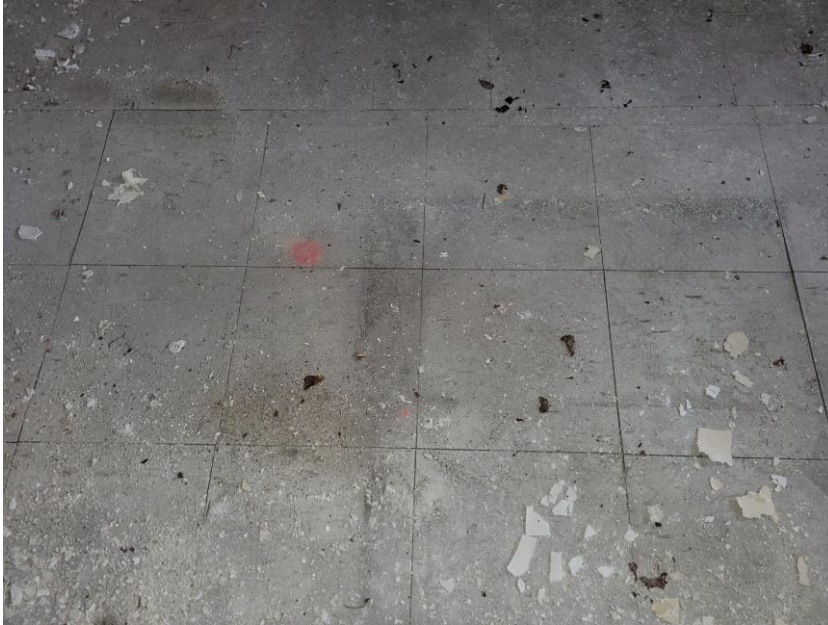
**Photo Location:**  
Room 313

**Material Description:**  
12" x 12" Vinyl Floor Tile  
and Mastic- Beige/Tan

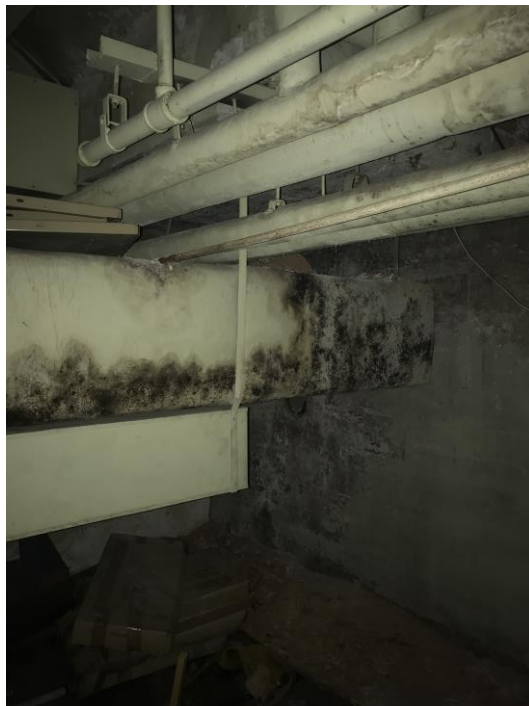
**Material Description:**  
Mag Block Pipe Insulation &  
MJP

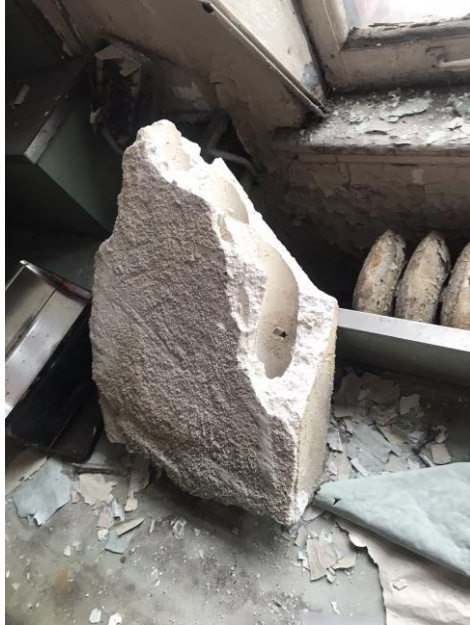
**Material Description:**  
Pyrobar

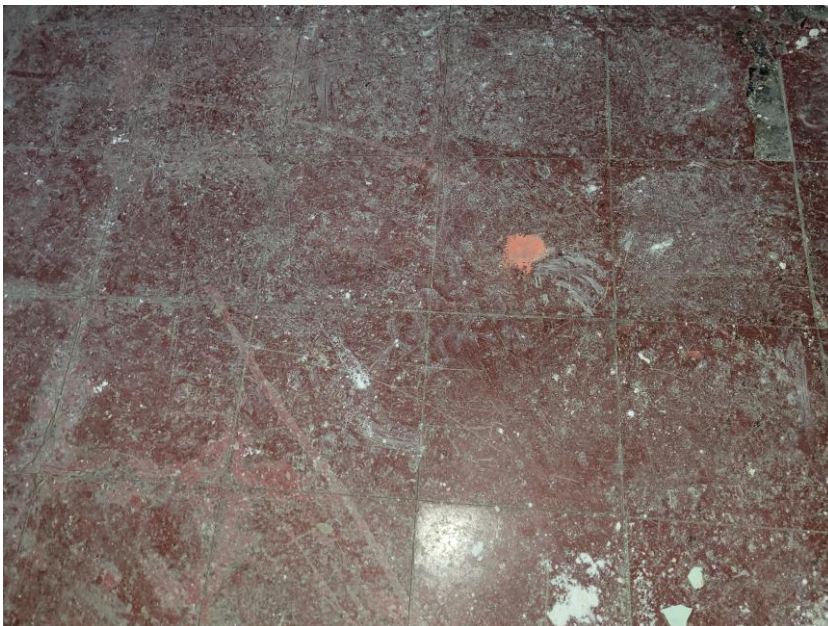
**Photo Location:**  
406

**Material Description:**  
9" x 9" Vinyl Floor Tile and  
Mastic- Peach, Red, White,  
Black

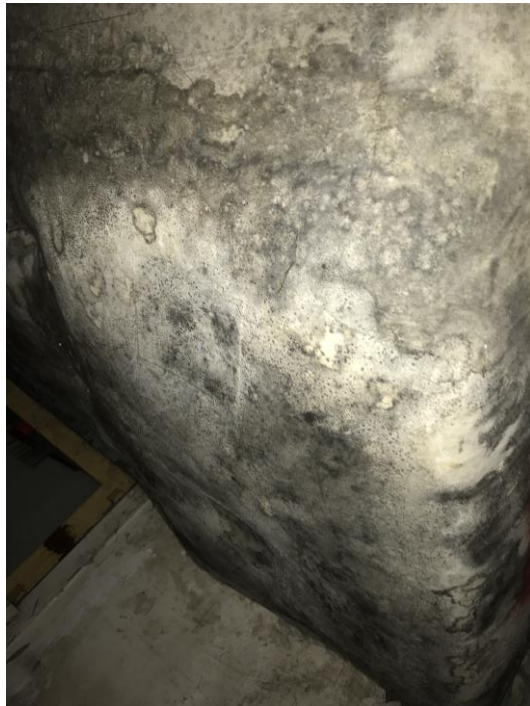
**Photo Location:**  
Room B-9

**Material Description:**  
Canvas over Fiberglass  
Insulation over Fan Housing

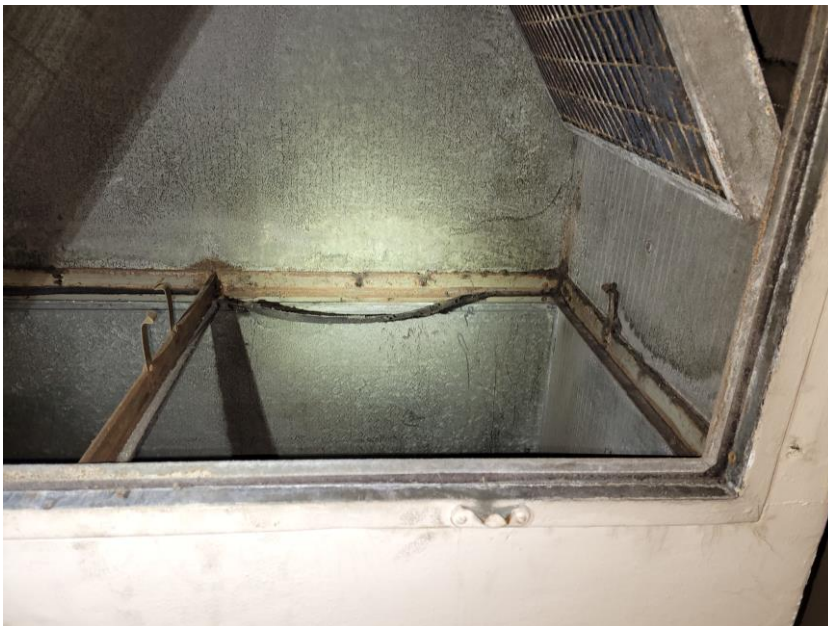
**Photo Location:**  
5<sup>th</sup> Floor Mechanical Room

**Material Description:**  
Interior Duct Fiberglass  
Insulation/ Adhesive

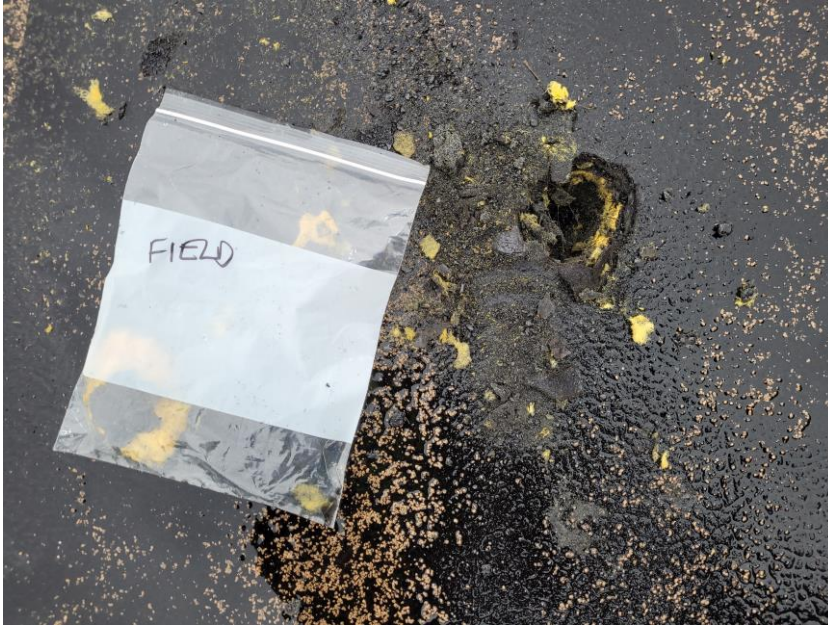
**Photo Location:**  
Roof

**Material Description:**  
Roof Field

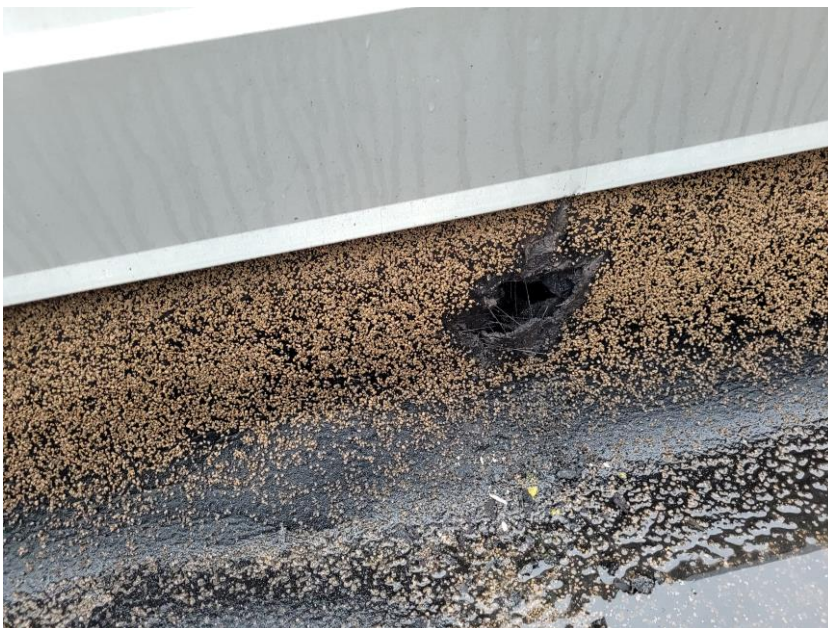
**Photo Location:**  
Roof

**Material Description:**  
Roof Flashing

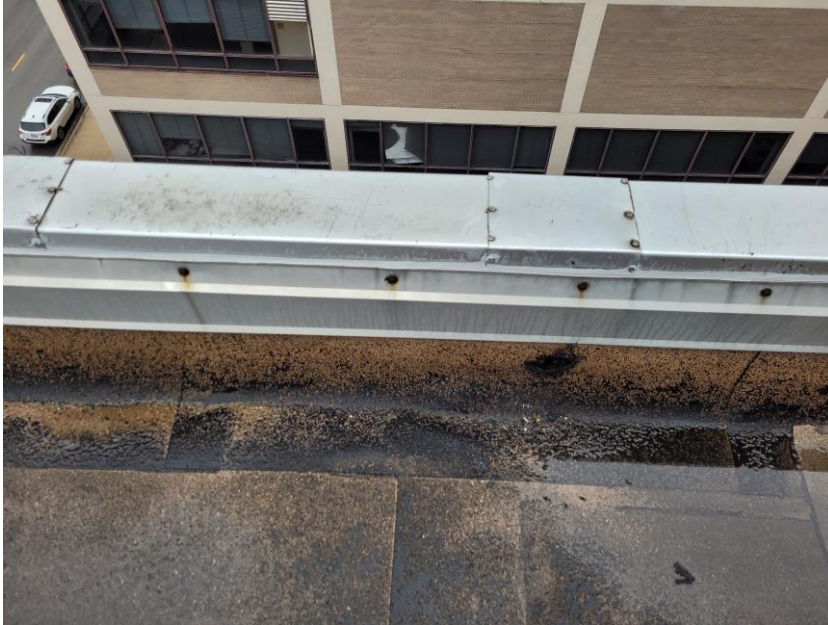
**Photo Location:**  
Roof

**Material Description:**  
Roof Couping Sealant

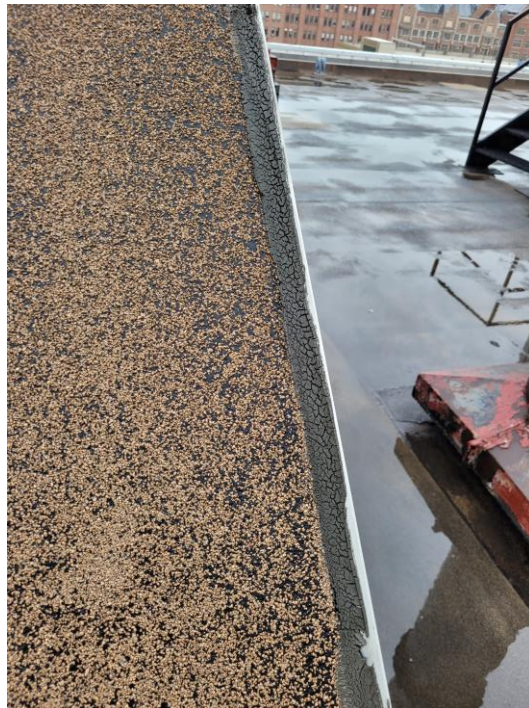
**Photo Location:**  
Roof

**Material Description:**  
Roof Field Sealant

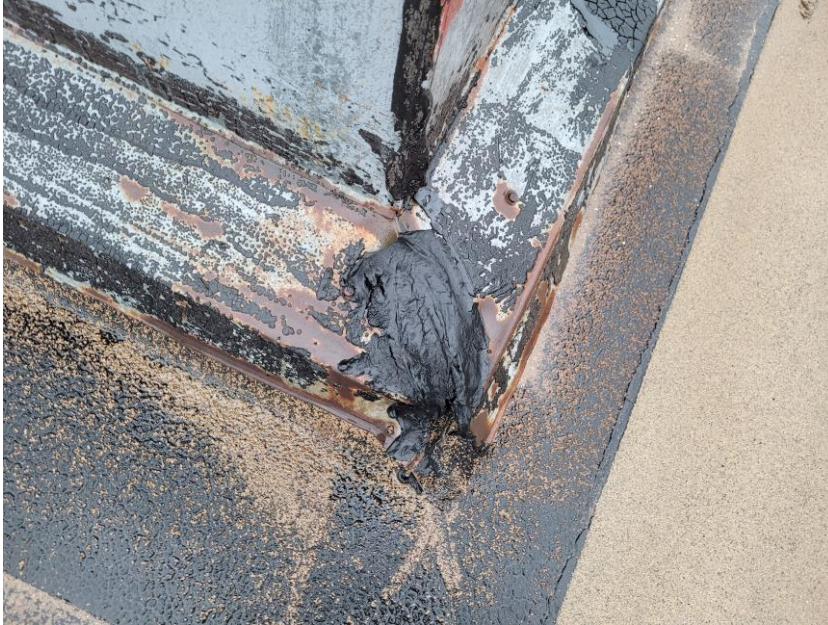
**Photo Location:**  
Roof

**Material Description:**  
Roof AHU Duct Sealant

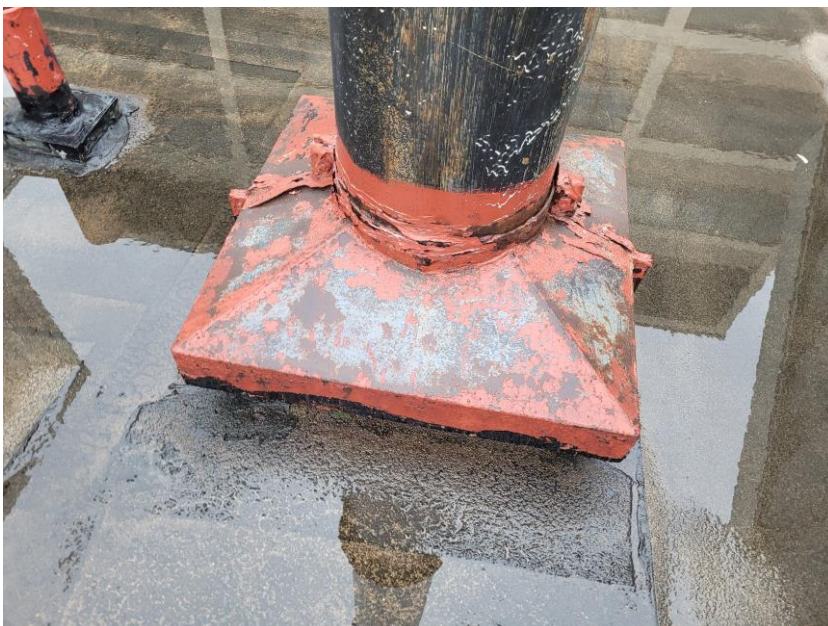
**Photo Location:**  
Roof

**Material Description:**  
Roof Chimney Sealant
